Attachment 1: Existing Conditions Photos

Existing Conditions Photos

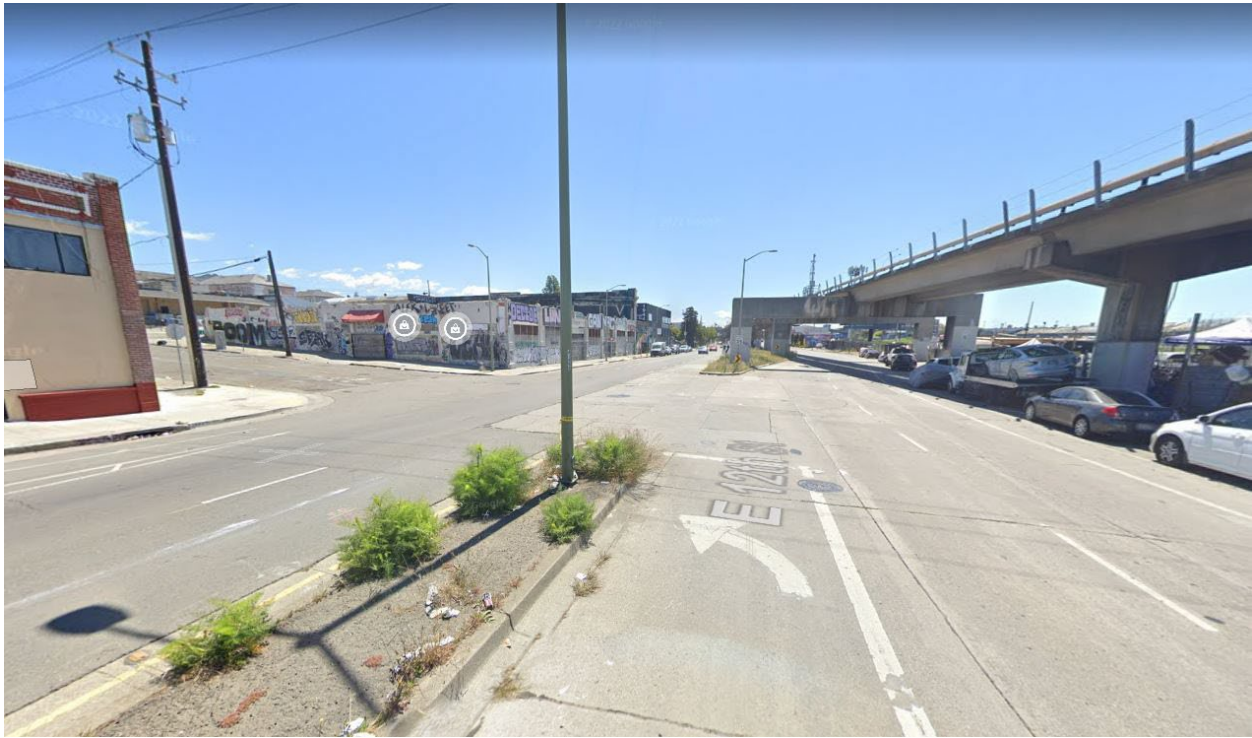
H-6 | E12th Street at 19th Avenue in Oakland: Lack of marked pedestrian crossings for long stretches of E12th Street leads to jaywalking and unsafe conditions

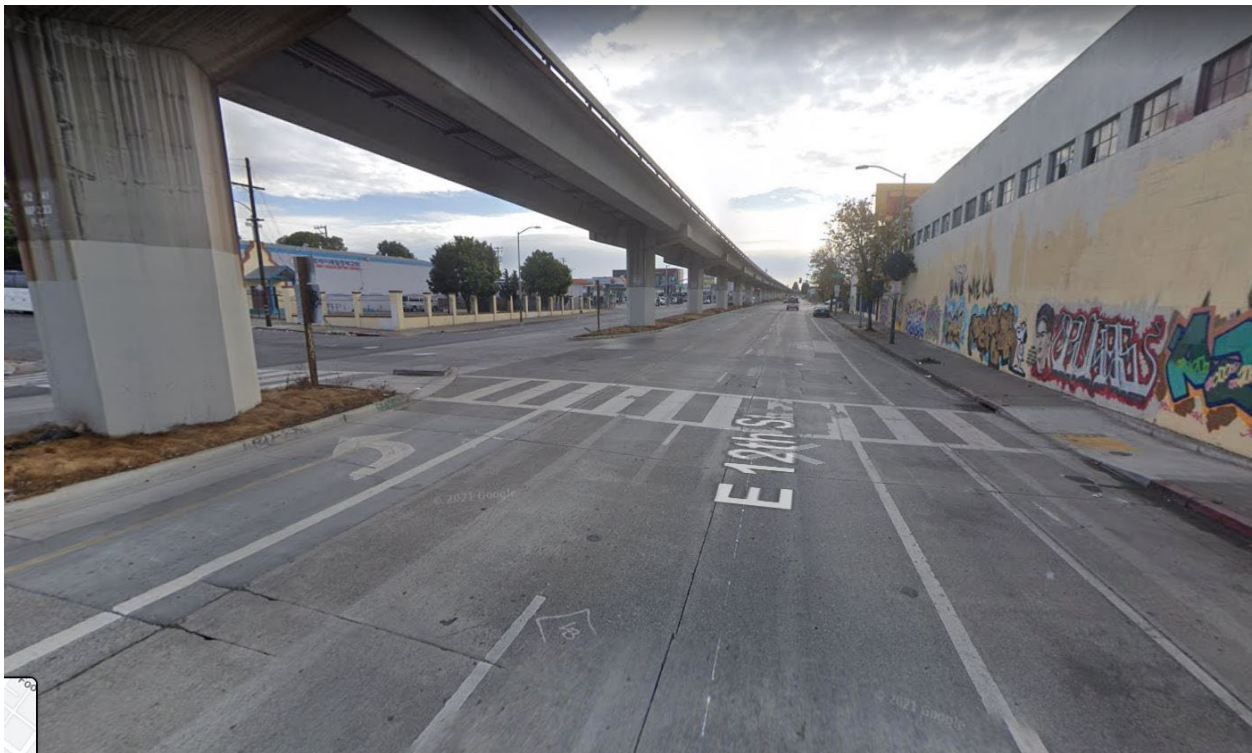
H-7 | E12th Street at 22nd Avenue in Oakland: Bike lanes are discontinuous & require cyclists to weave across multiple lanes to make left turns

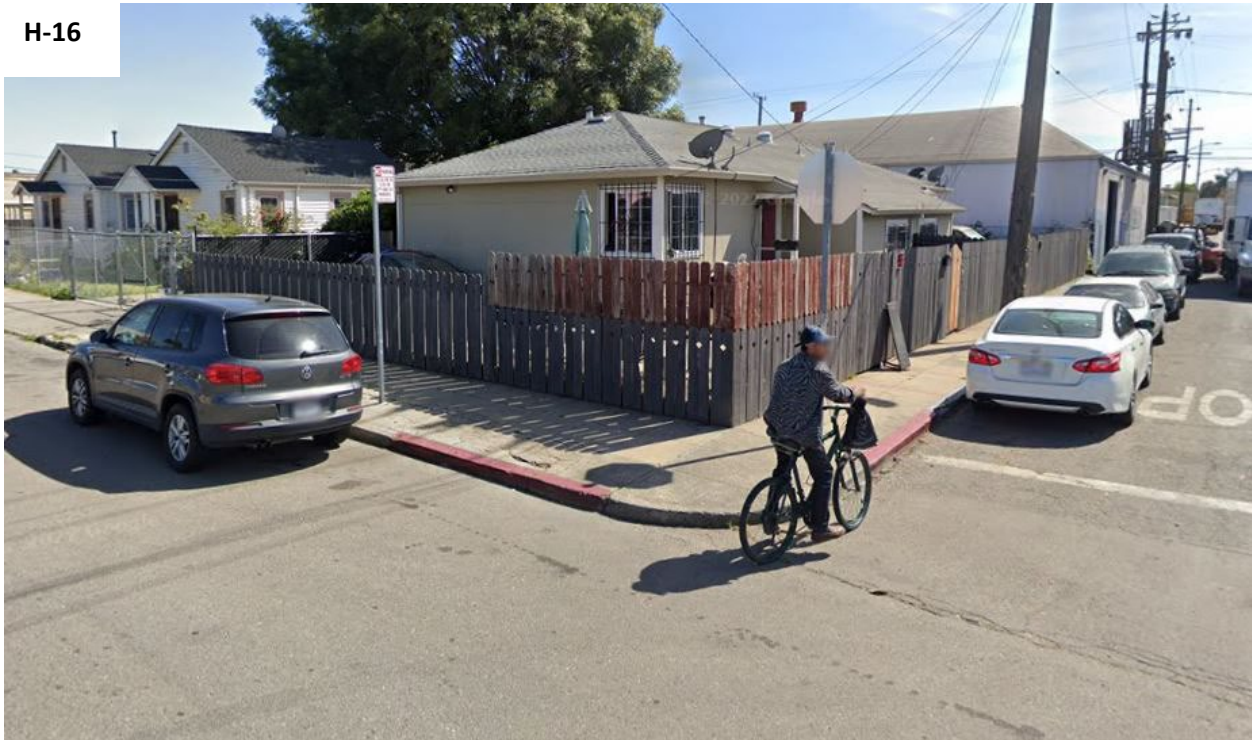
H-16

H-16-17 | Pippin Street in Oakland: Several intersections have not curb ramps

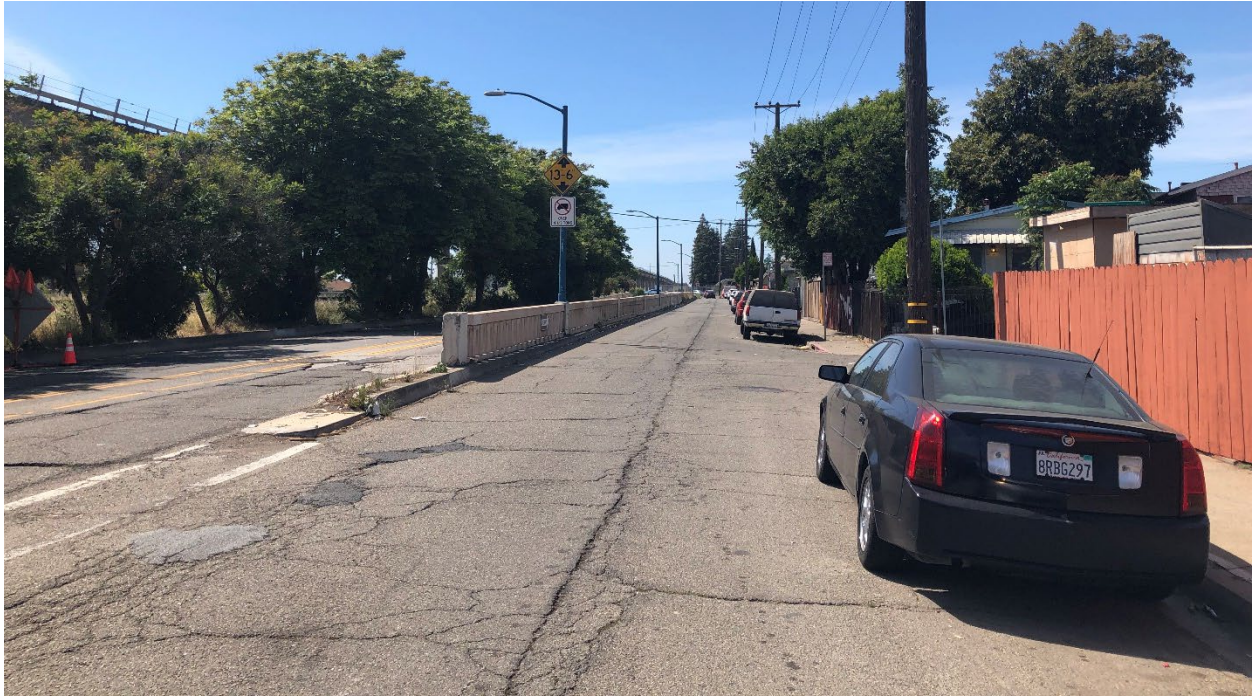
H-18 | San Leandro Street at Blenheim Street in Oakland: Narrow pavement widths do not allow for safe passing of bicyclists

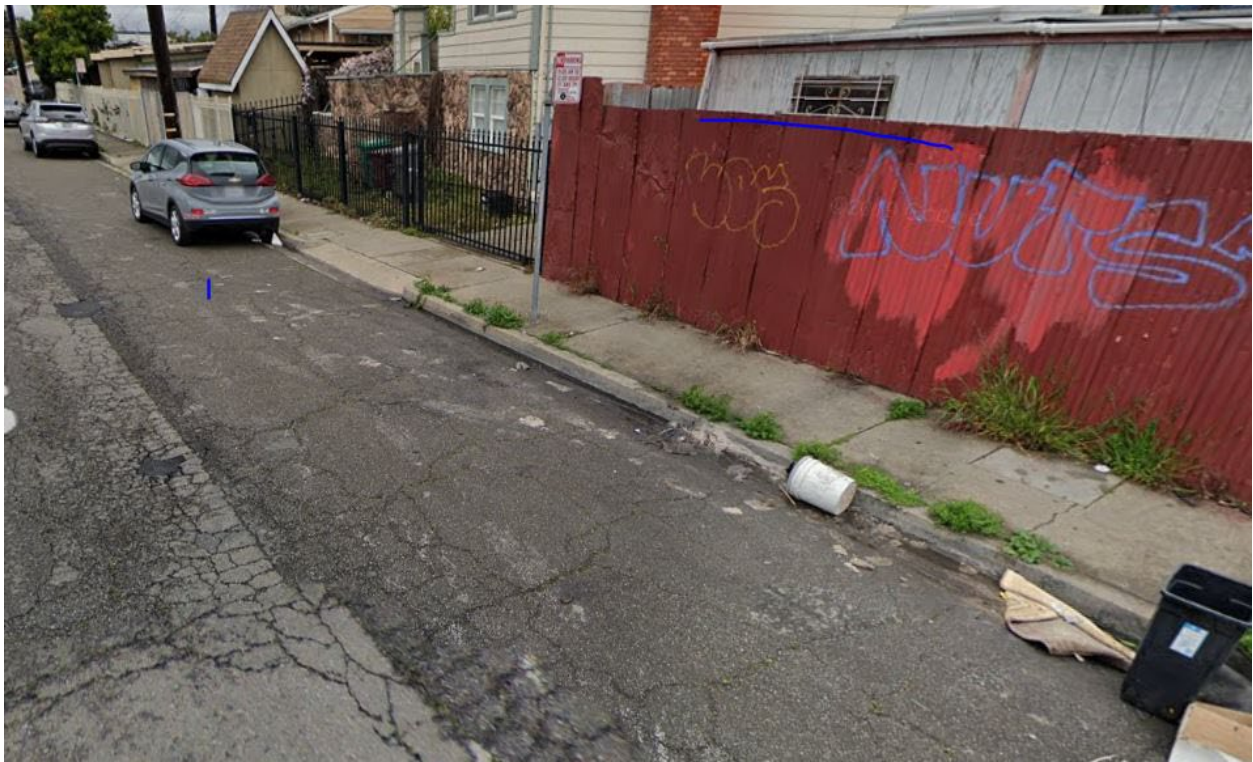
H-19 | San Leandro Street at Blenheim Street in Oakland: Pedestrians and cyclists must contend with narrow sidewalks and poor pavement conditions
