# Attachment 1: Existing Conditions Photos

**Existing Conditions Photos**

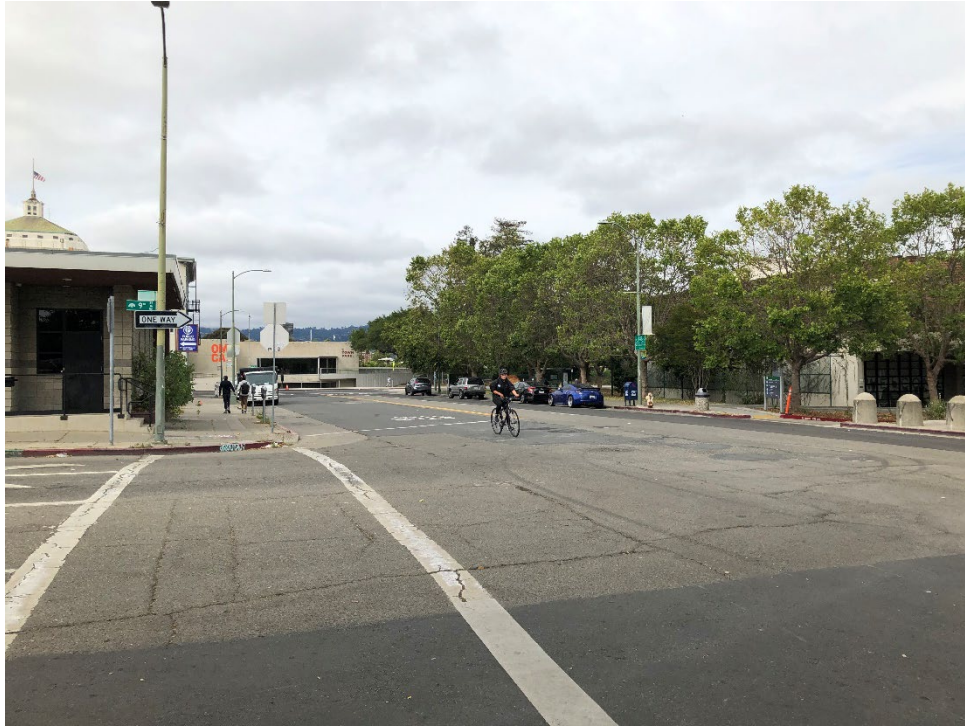
**H-1 | 9<sup>th</sup> and Fallon Streets in Oakland:** There is a general lack of low-stress facilities within the EBGW corridor. By Lake Merritt BART and Laney College, cyclists must share the road with vehicular traffic

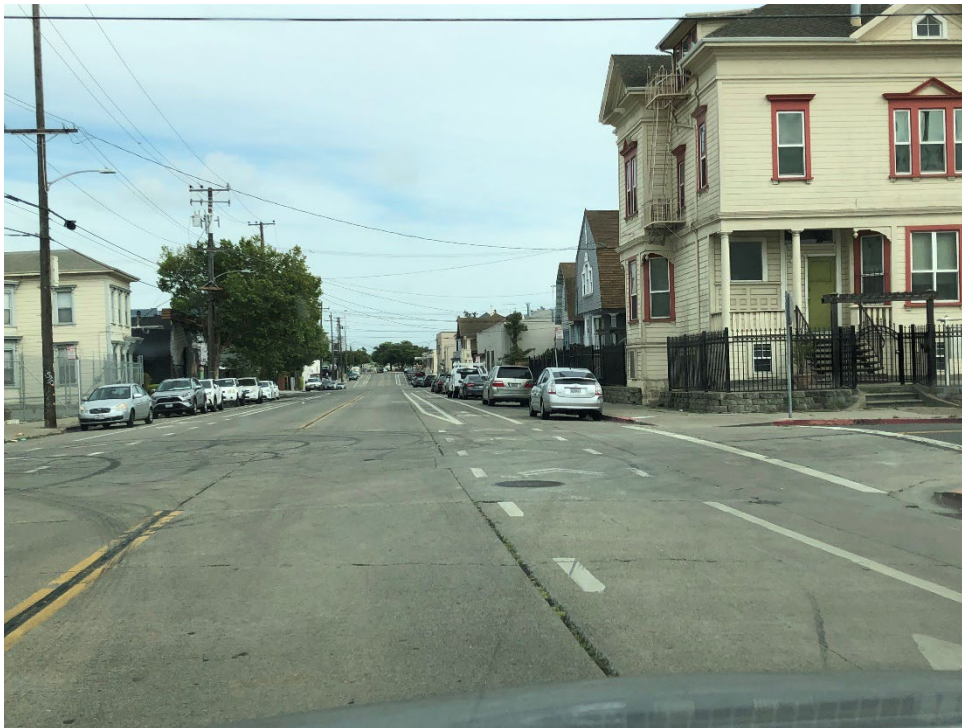
**H-2 | E10<sup>th</sup> Street and 6<sup>th</sup> Avenue in Oakland:** Many sections of the corridor lack marked crosswalks for several consecutive blocks

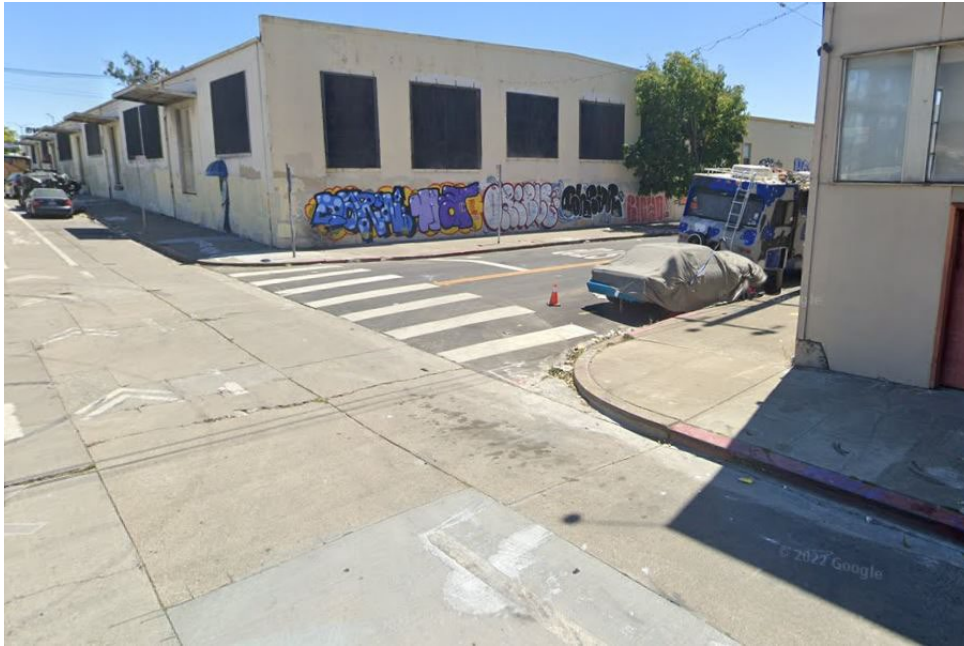
**H-3 | E10<sup>th</sup> Street at 8<sup>th</sup> Avenue in Oakland:** Several blocks on E10<sup>th</sup> Street have no curb ramps or are otherwise not ADA compliant

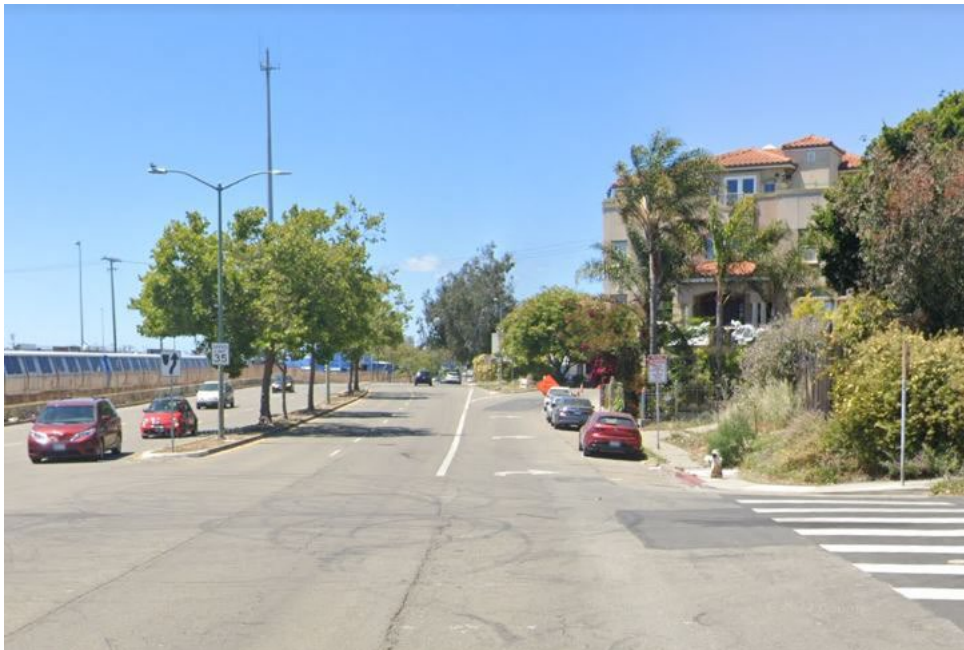
**H-4 | E8<sup>th</sup> Street at 10<sup>th</sup> Avenue in Oakland:** Cyclists traveling northbound have to weave across lanes to avoid getting trapped at the right-only lane

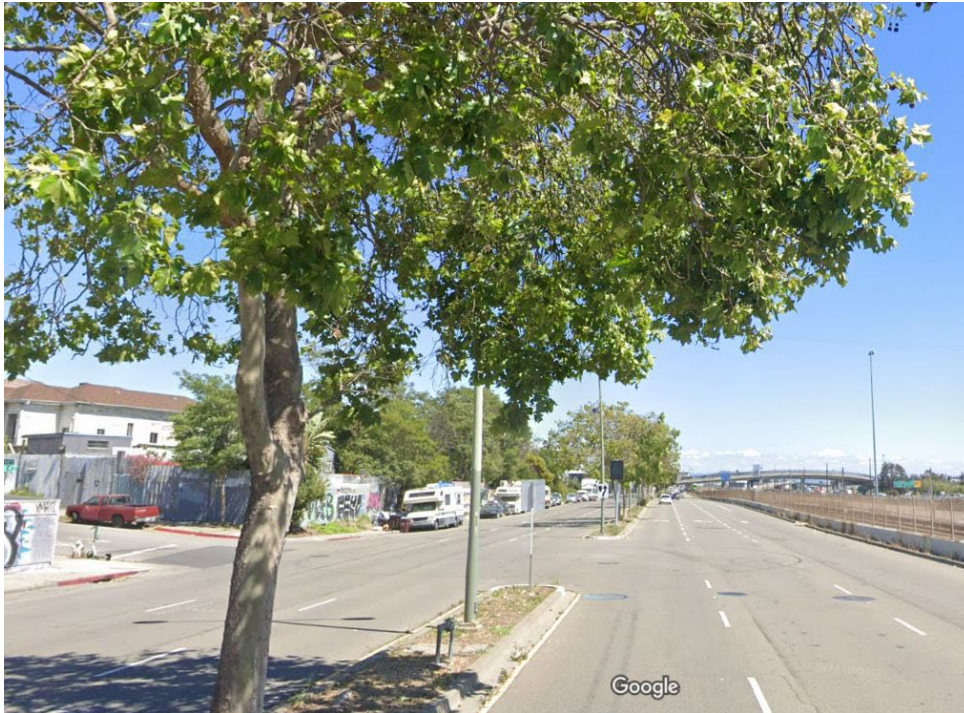
**H-4 | E8<sup>th</sup> Street at 11<sup>th</sup> Avenue in Oakland:** Cyclists must contend high speeds and volumes on E8<sup>th</sup> Street (13,700 vpd/48 mph)

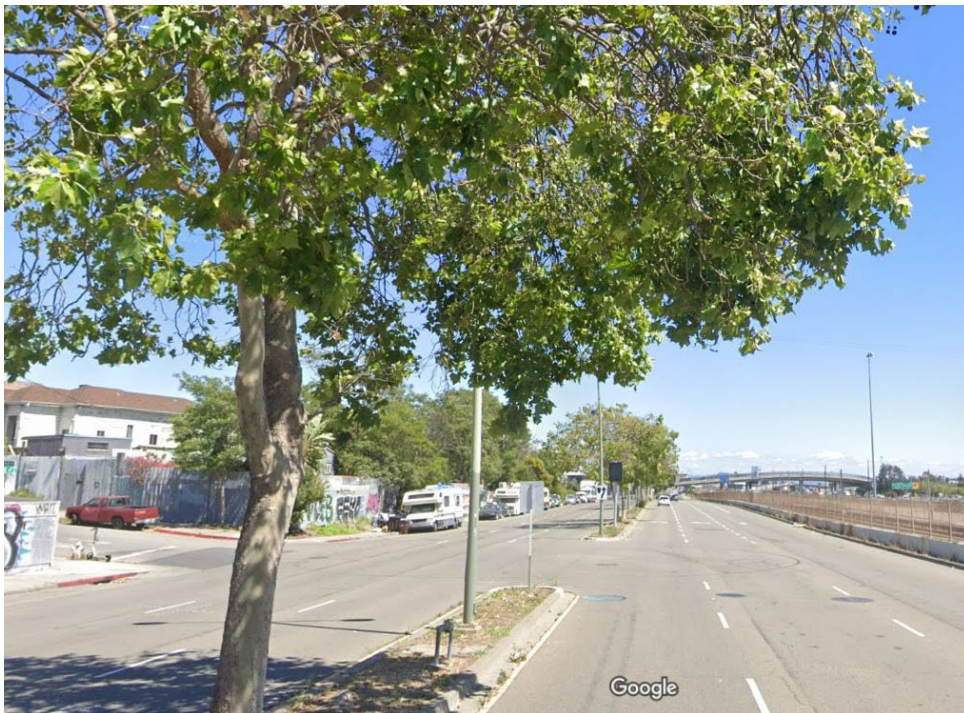
**H-5 | E8<sup>th</sup> Street at 12<sup>th</sup> Avenue in Oakland:** Unprotected left turns where turning vehicles must attempt to scan for a gap in opposing traffic and identify any crossing bicyclists and pedestrians

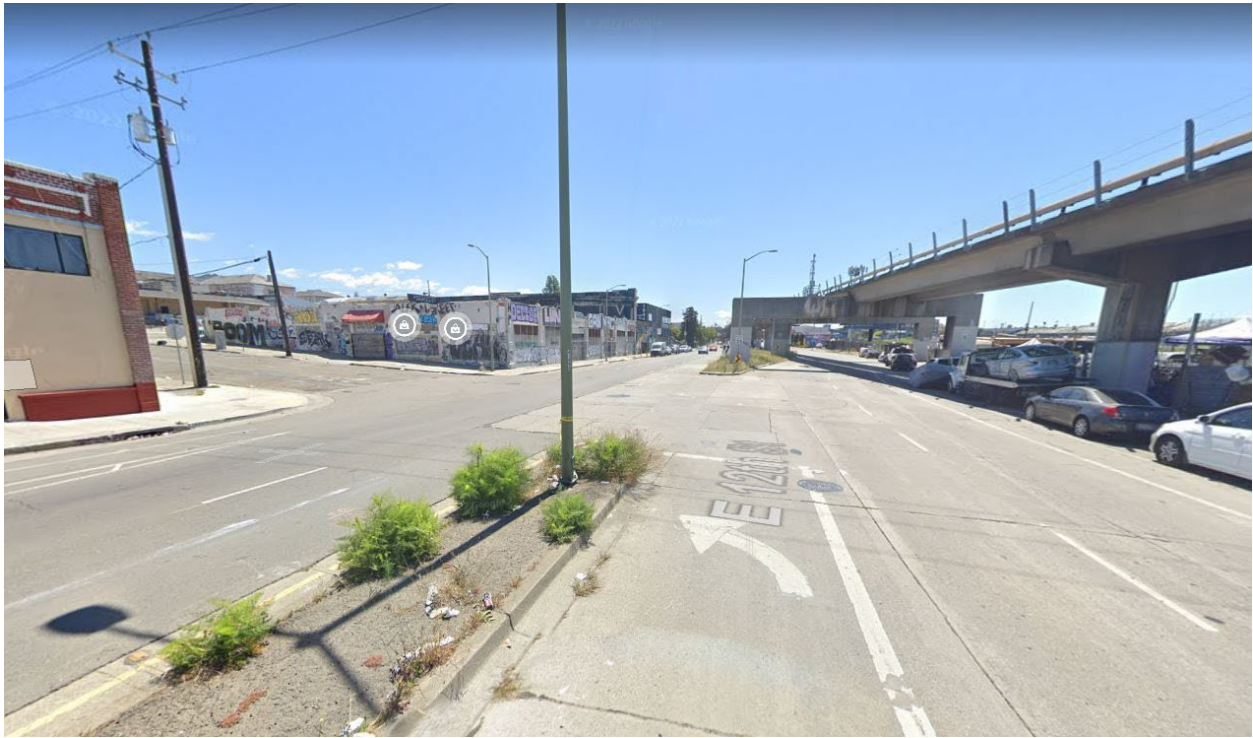
**H-6 | E12<sup>th</sup> Street at 19<sup>th</sup> Avenue in Oakland: Lack of marked pedestrian crossings for long stretches of E12<sup>th</sup> Street leads to jaywalking and unsafe conditions**

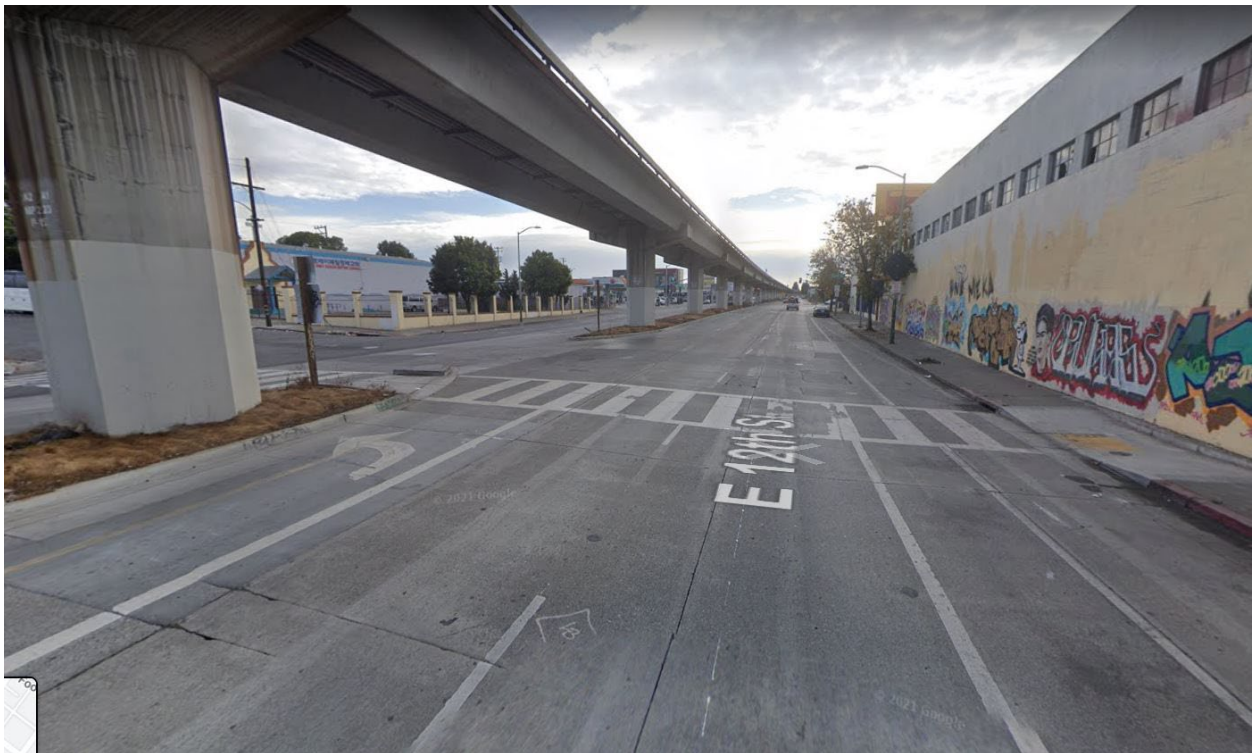
**H-7 | E12<sup>th</sup> Street at 22nd Avenue in Oakland: Bike lanes are discontinuous & require cyclists to weave across multiple lanes to make left turns**

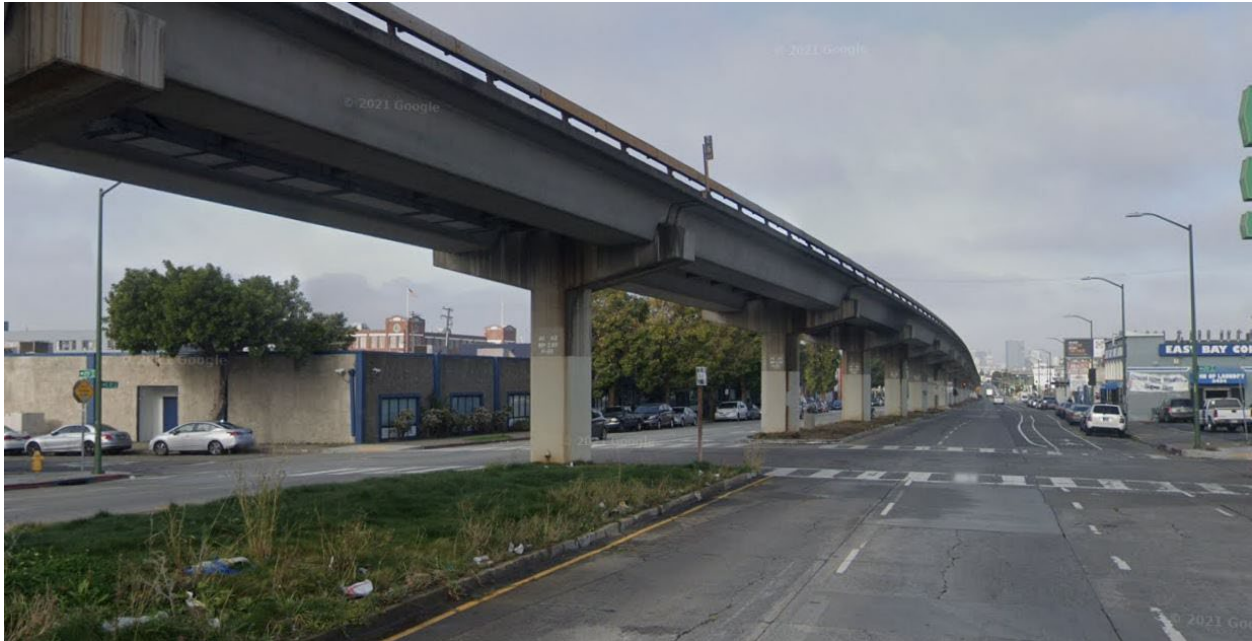
**H-8 |** E12<sup>th</sup> Street at 25<sup>th</sup> Avenue in Oakland: Unprotected left turns on E12<sup>th</sup> Street are aggravated by poor sight distance due to the presence of the BART aerial structure columns

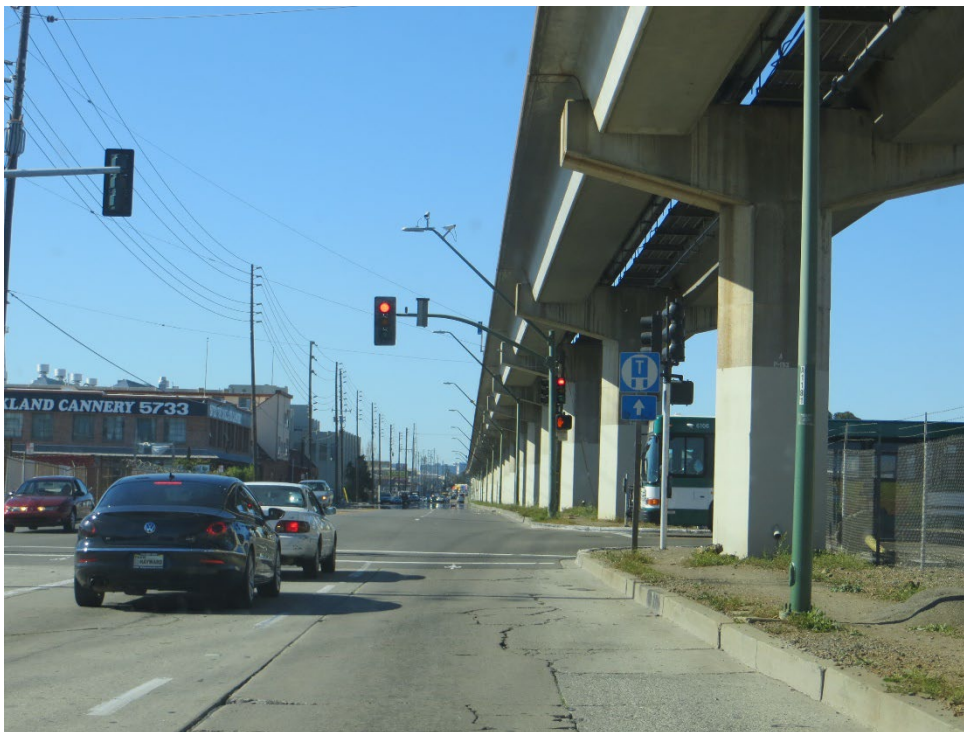
**H-9 |** San Leandro Street at Seminary Avenue in Oakland: There is a lack of pedestrian and bicycle facilities for long stretches of San Leandro Street, and no protected bicycle facilities within the corridor, except the constructed Segment 7A multi-use path from 75<sup>th</sup> to 85<sup>th</sup> Avenues

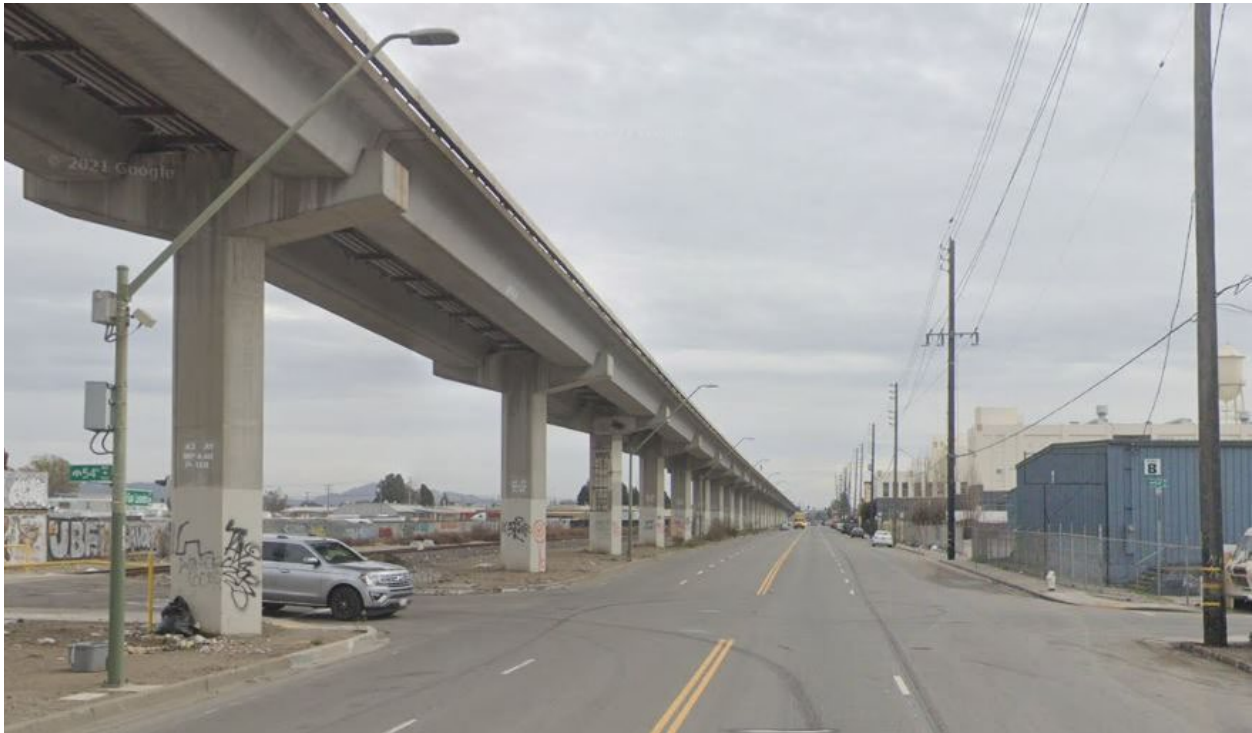
**H-10** | San Leandro Street at 54<sup>th</sup> Avenue in Oakland: There are no marked crosswalks for long distances on San Leandro Street – pedestrians and cyclists must cross four lanes of traffic with no

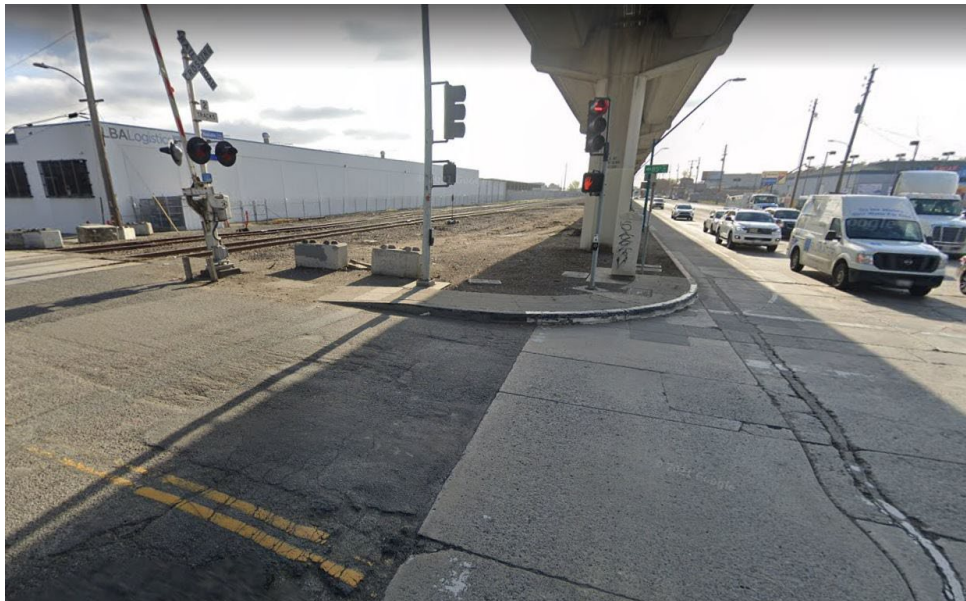
**H-11** | San Leandro Street at 85<sup>th</sup> Avenue in Oakland: Paths of travel along and across San Leandro Street are discontinuous

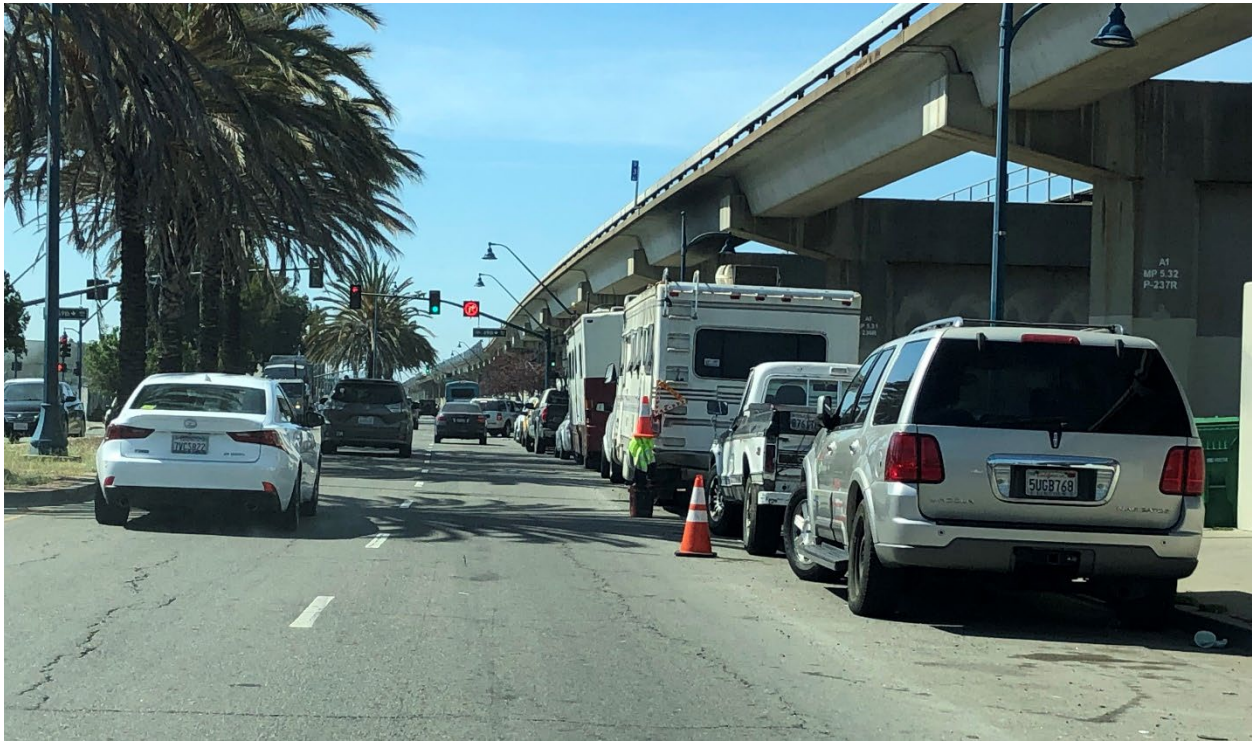
**H-12** | San Leandro Street south of 69<sup>th</sup> Avenue in Oakland: There is no separation of bikes from traffic north of Coliseum BART

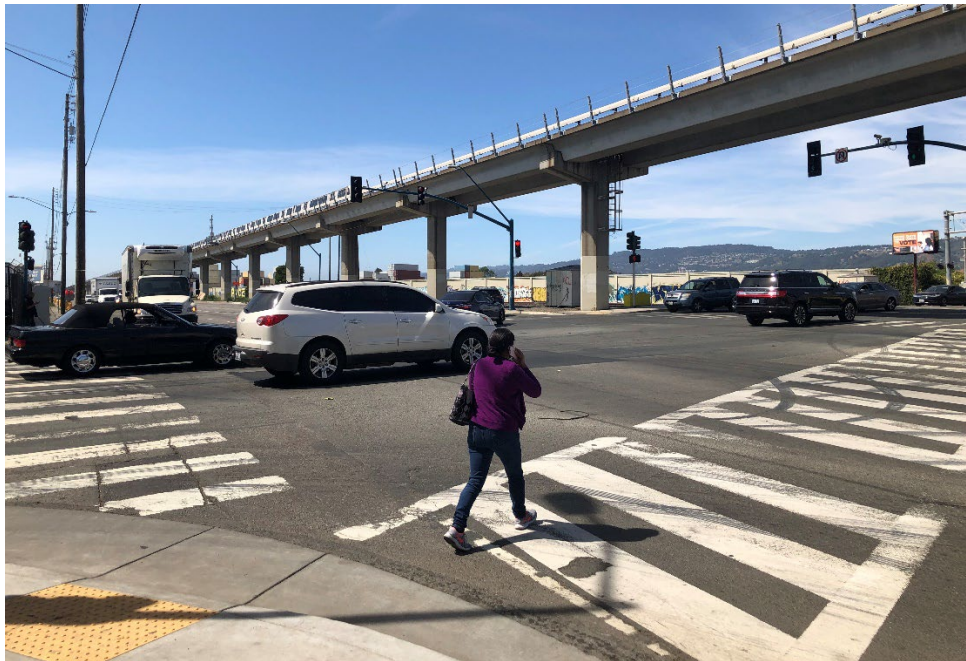
**H-13** | San Leandro Street at 98<sup>th</sup> Avenue in Oakland: There are long crossings with no pedestrian refuge or curb bulbs

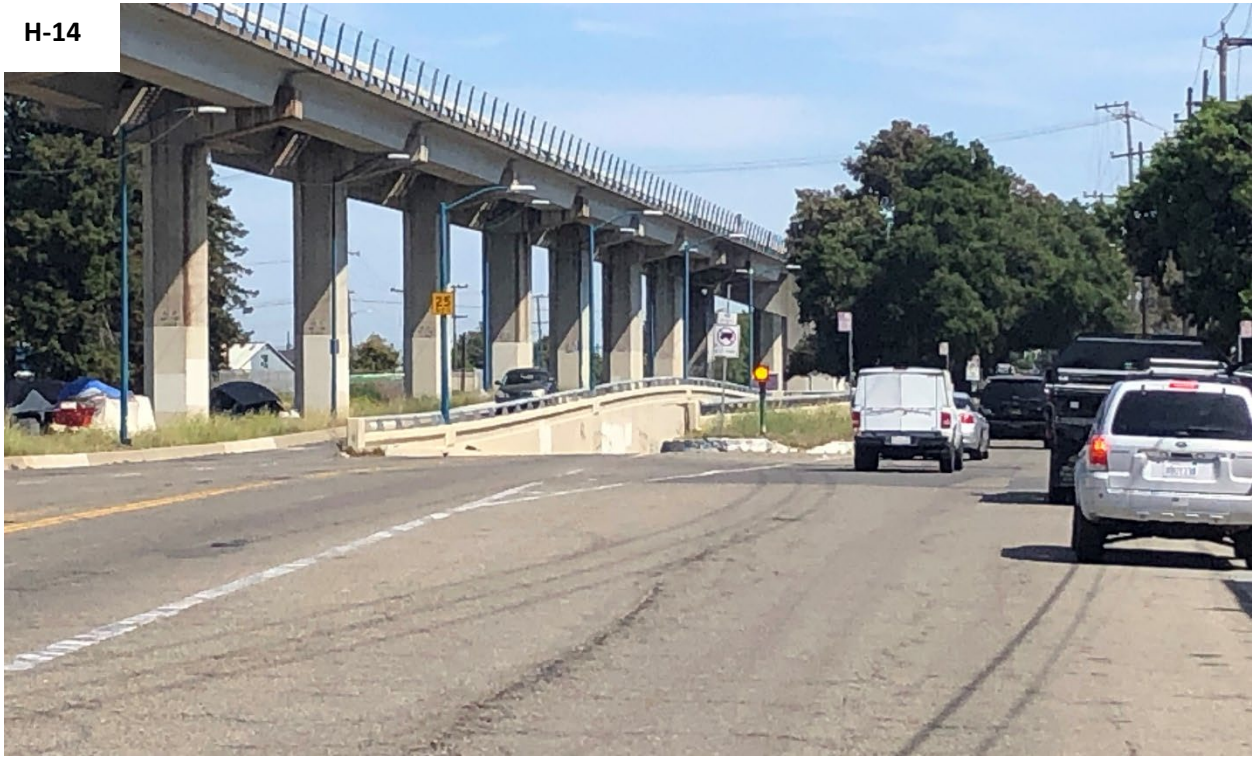
**H-14**

**H-14-15** | San Leandro Street Underpass at 105<sup>th</sup> Avenue in Oakland: There is a lack of signage to warn pedestrians and cyclists of unsafe road conditions, and no direct route southbound on San Leandro Street

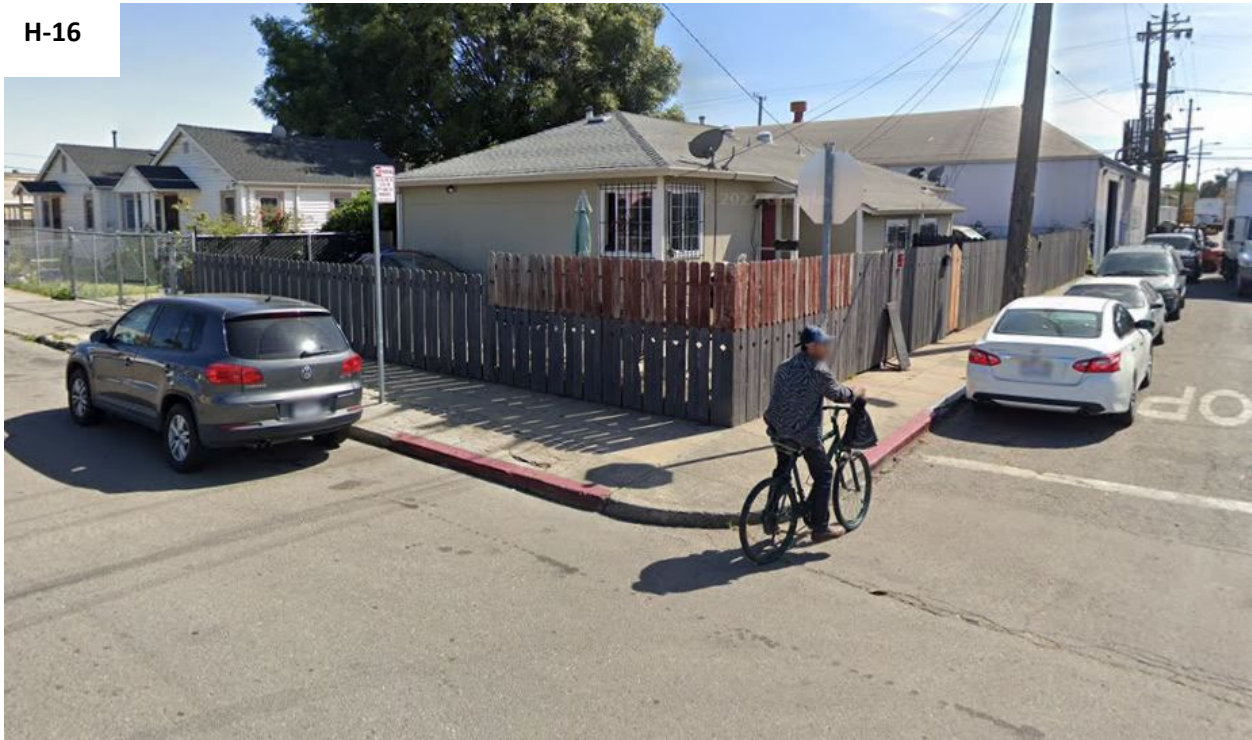
**H-16**

**H-16-17** | Pippin Street in Oakland: Several intersections have not curb ramps

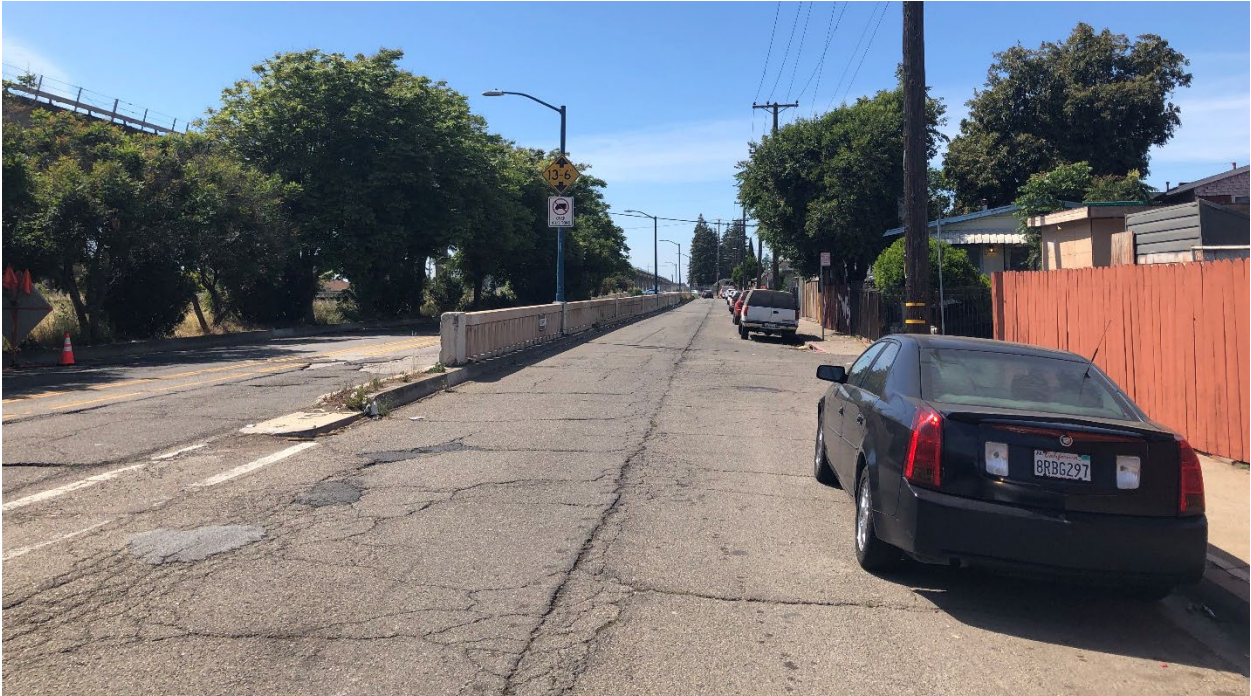
**H-18** | San Leandro Street at Blenheim Street in Oakland: Narrow pavement widths do not allow for safe passing of bicyclists

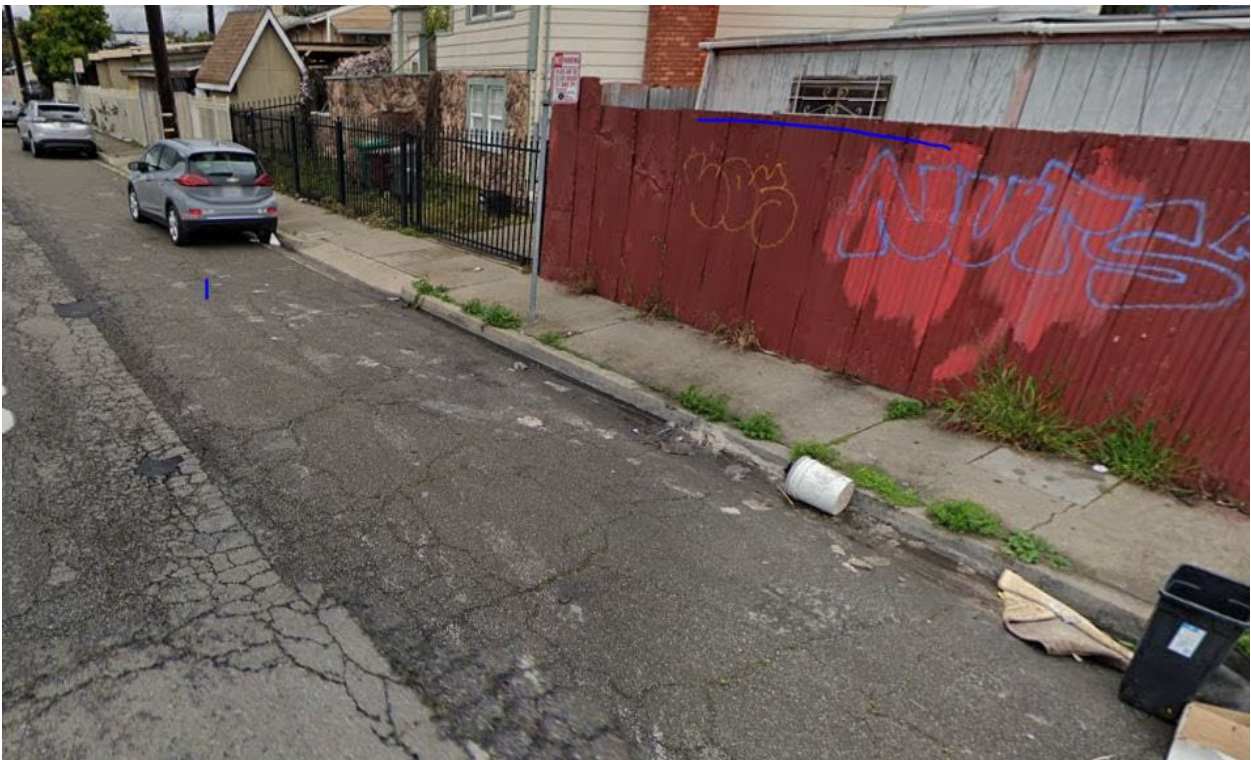
**H-19** | San Leandro Street at Blenheim Street in Oakland: Pedestrians and cyclists must contend with narrow sidewalks and poor pavement conditions

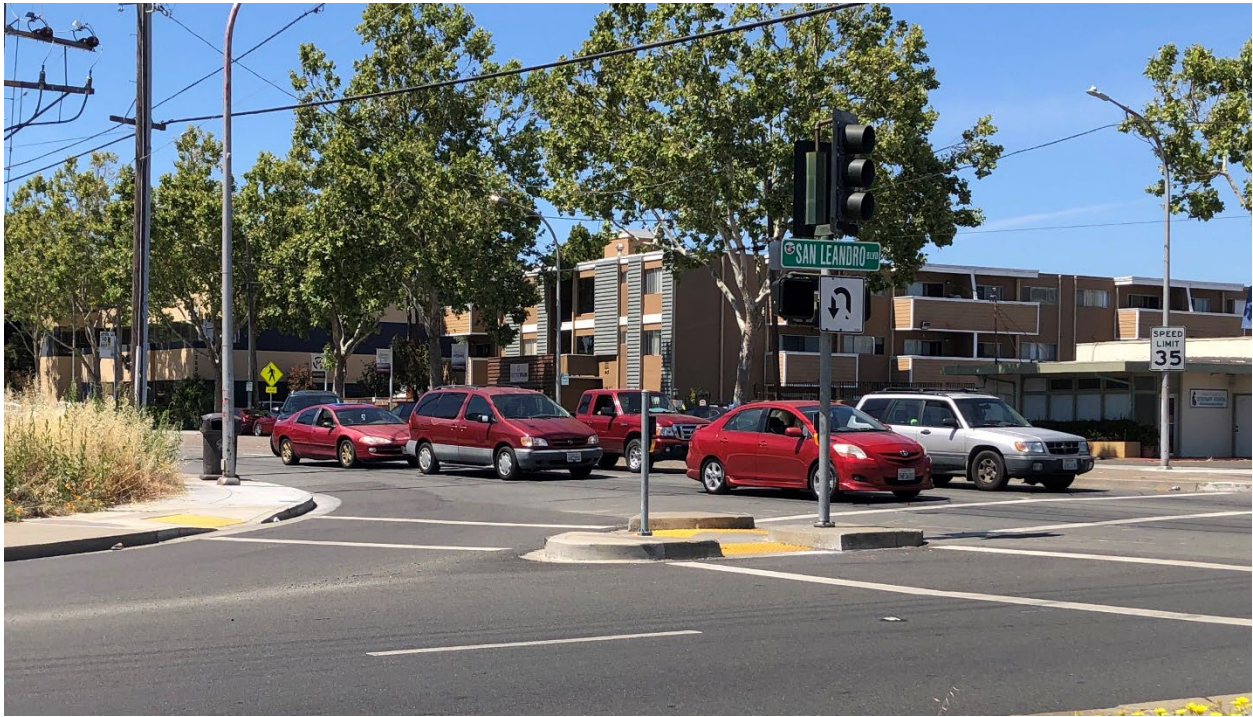
**H-20** | San Leandro Boulevard at Washington Street in San Leandro: Free right turns cause conflicts with cyclists

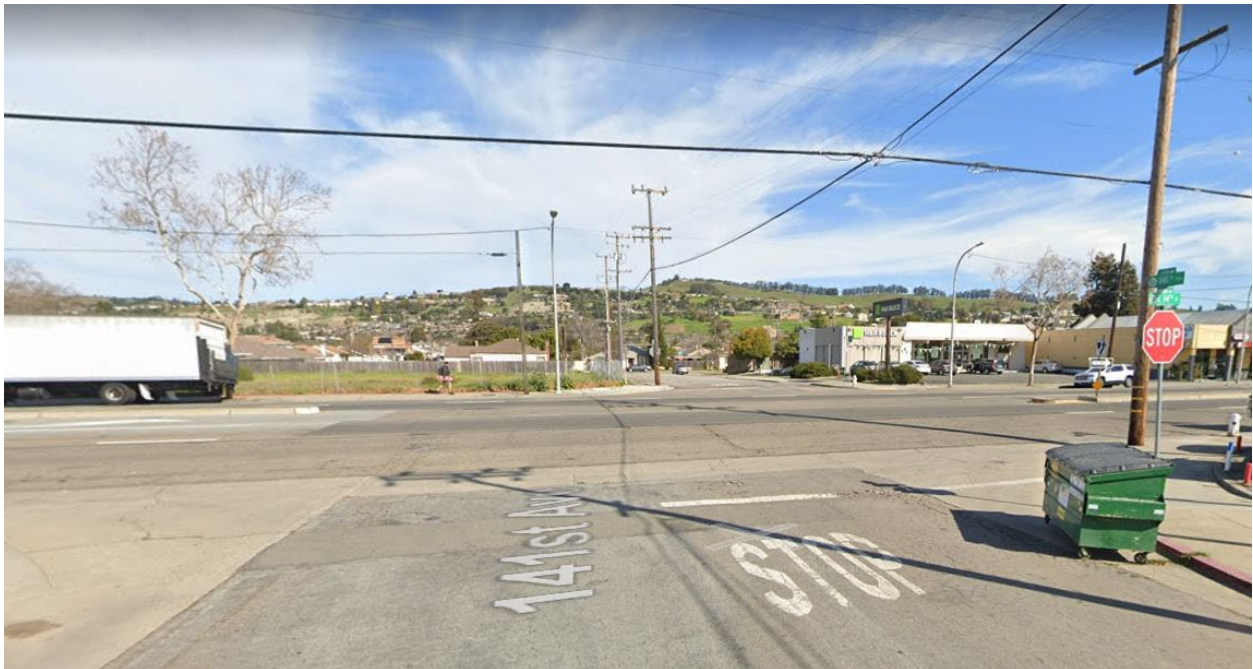
**H-21** | E 14<sup>th</sup> Street at 141<sup>st</sup> Avenue in San Leandro: Offset intersections add complexity to crossing maneuvers

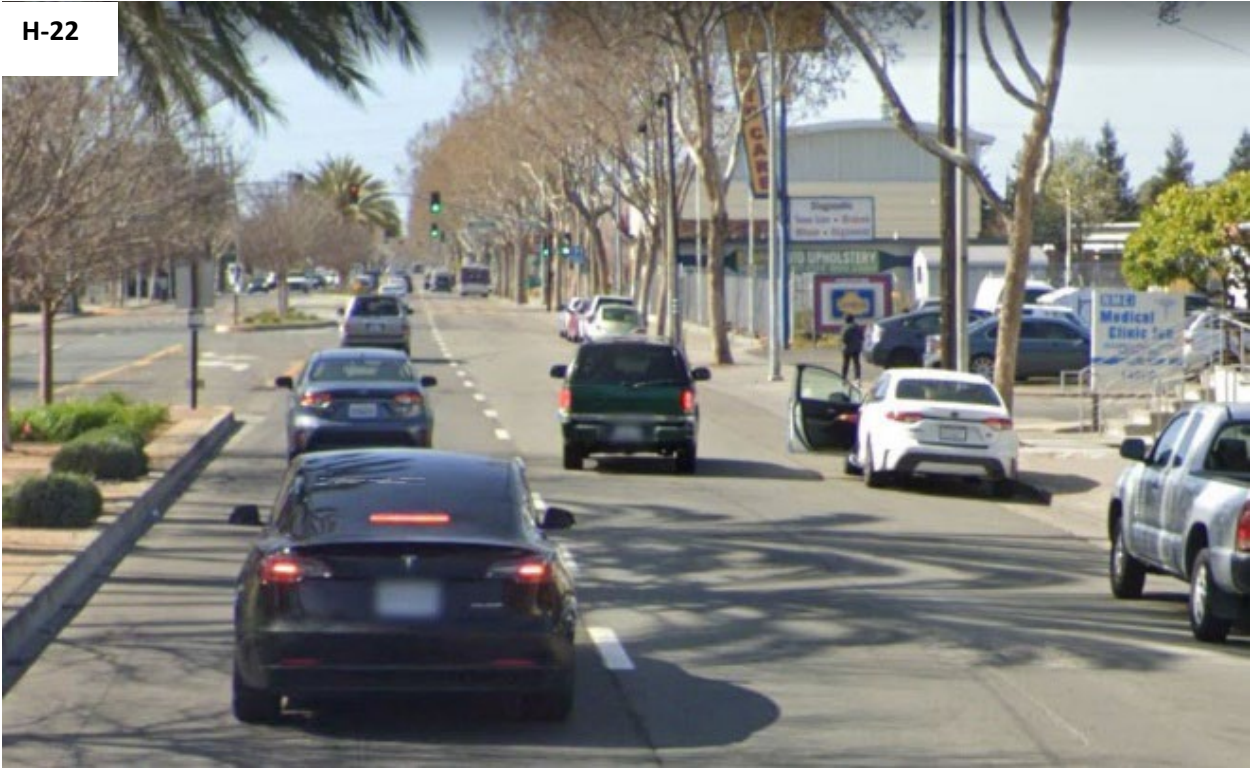
H-22

**H-22-23** | E14<sup>th</sup> Street in San Leandro: A lack of protected bike facilities within the corridor means cyclists must contend with car door openings and parking maneuvers

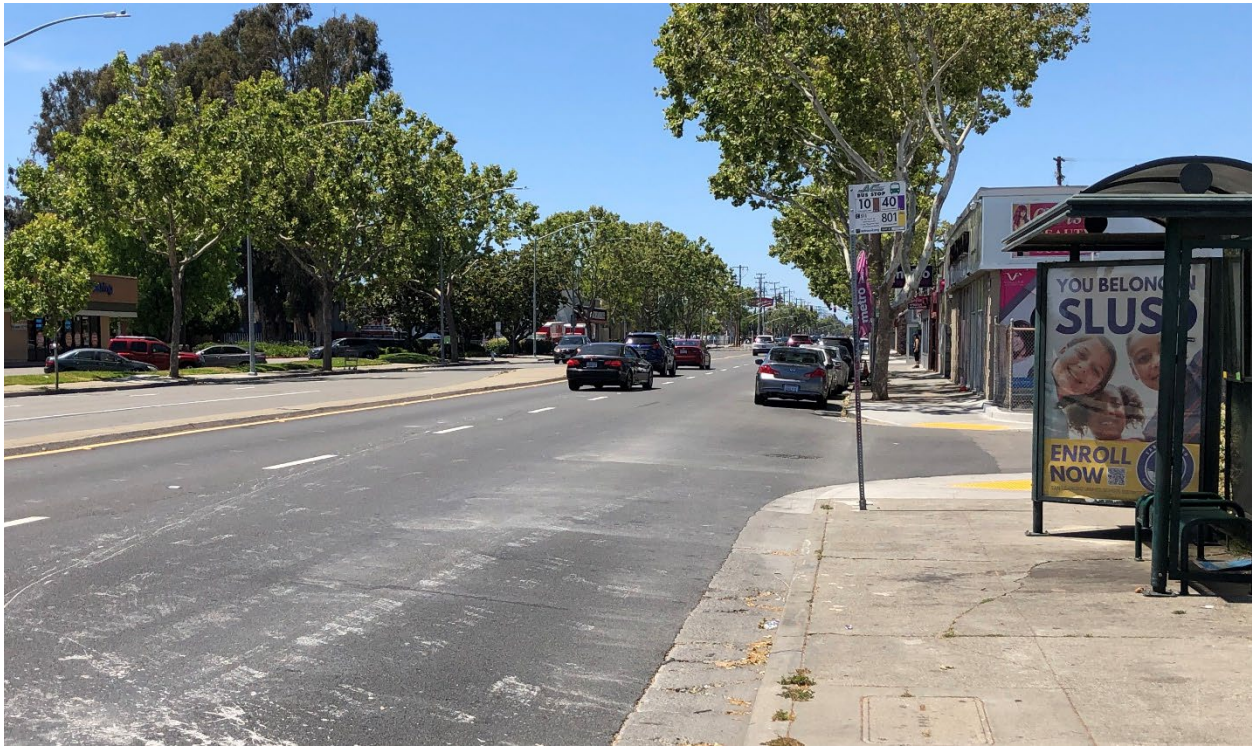
**H-24 | E14<sup>th</sup> Street in San Leandro:** There is a lack of crossing opportunities along East 14th, which is in the heart of a commercial district: there are locations where pedestrians must walk up to a quarter mile out of their way to get to a marked crosswalk

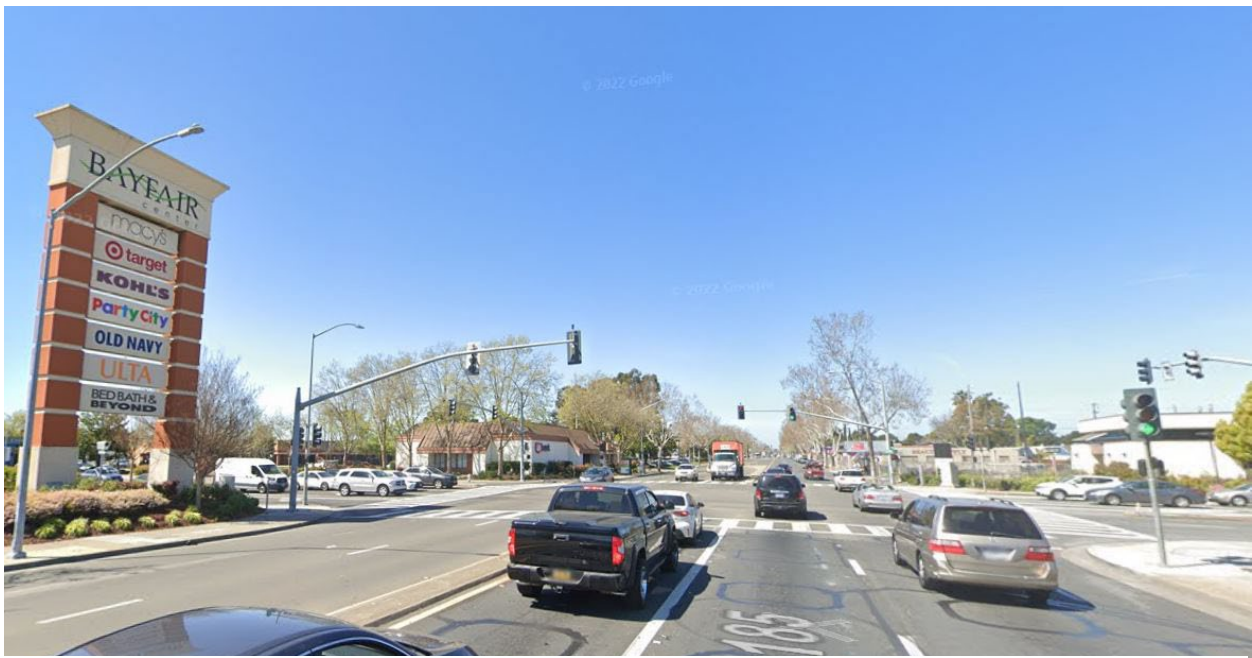
**H-25 | E14<sup>th</sup> Street at Fairmont Street in San Leandro:** There are no bike protected intersections within the corridor. Safety would be improved at busy intersections like E14<sup>th</sup> and Fairmont Drive
